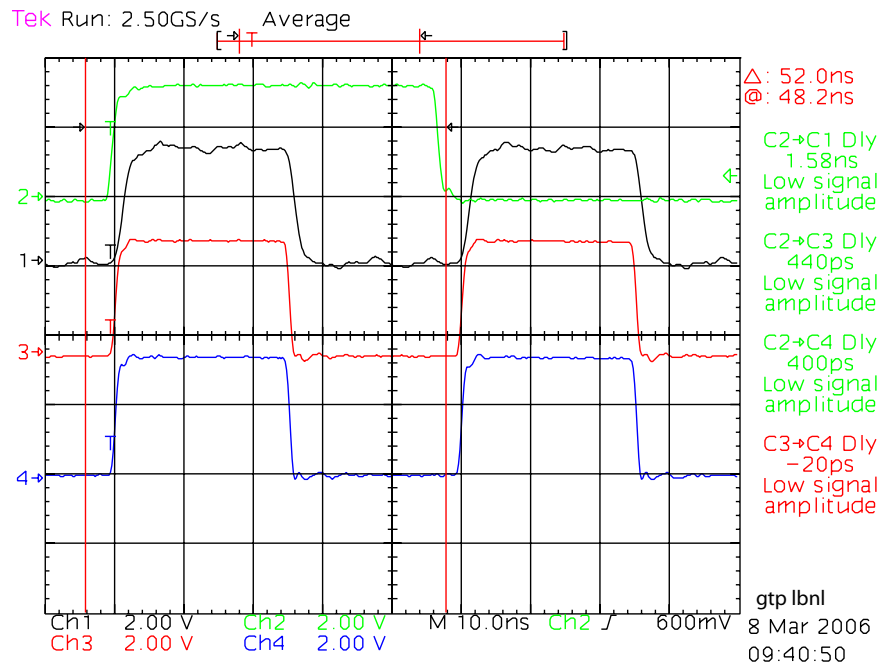
CH1: 20 MHz ADC Clock on DOR card

CH2: 10 MHz Reference from GPS clock

CH3: 20 MHz ADC Clock from DOM A Under Test

CH4: 20 MHz ADC Clock from DOM B Under Test

Temperature -55C causes negative skew of DOM Clock
